Report Number **BTC 18175F**

A REACTION TO FIRE TEST REPORT COVERING A SINGLE BURNING ITEM TEST ON CONTEGO HS INTUMESCENT FIRE BARRIER PAINT (HIGH SOLIDS VERSION), CONDUCTED IN ACCORDANCE WITH EN 13823: 2010.

Test Date: 18<sup>th</sup> April 2013

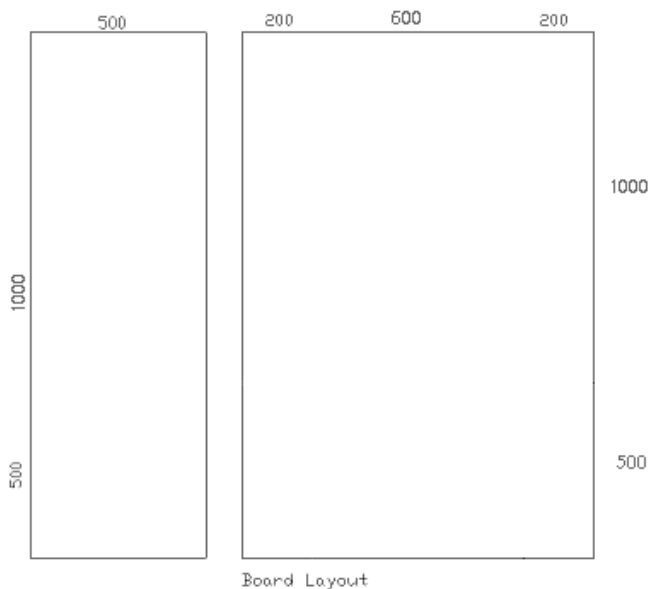
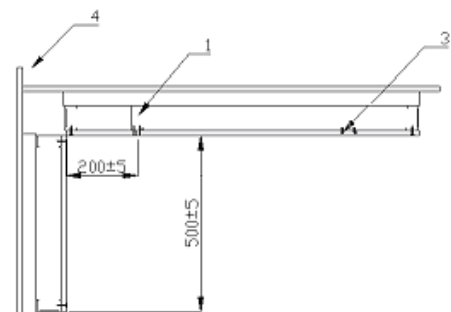
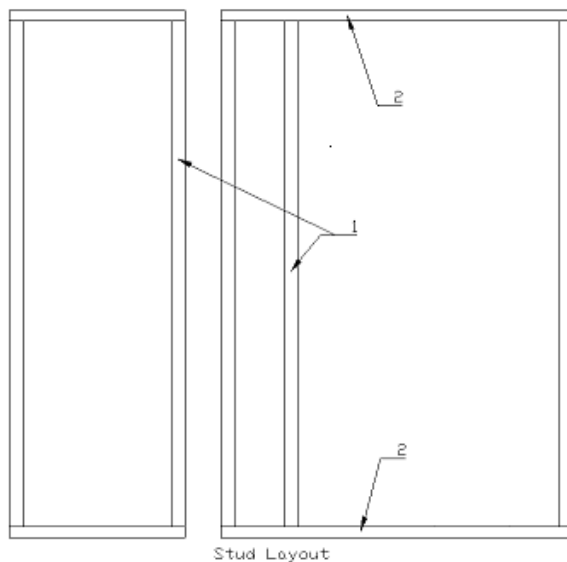
### TEST SPECIMEN MOUNTING

The boards were tested in a corner configuration comprising two wings, constructed using GypFrame 72C50 channel and GypFrame 70S50 studs.

The boards were screw fixed to the metal frame using 36mm Gyproc Drywall Screws at 300mm  $\pm$  30mm centres measured along the length of each supporting member.

A calcium silicate backing board was positioned freely against the GypFrame with a second metal framework secured with brackets behind it to hold it in place.

- 1. 70x50 Stud
- 2. 72x50 Channel
- 3. Specimen
- 4. Backing Board

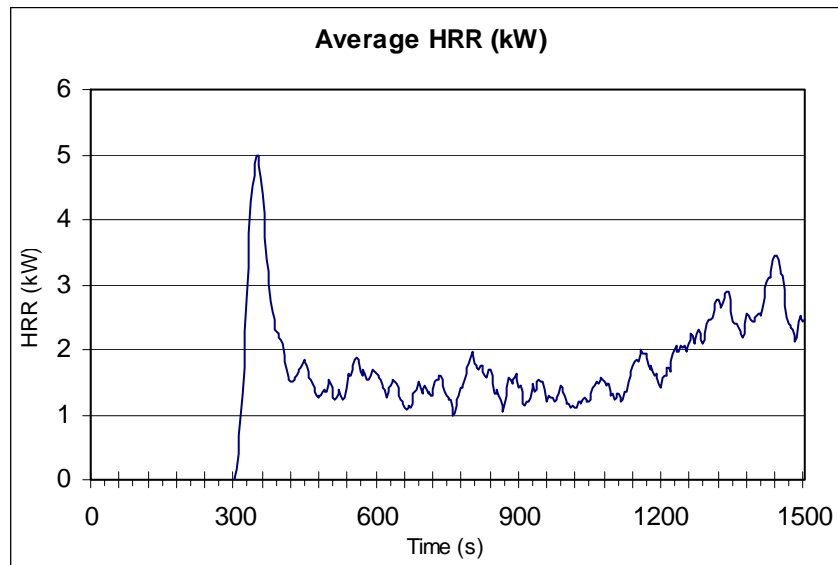
Figure 1a. Relative heat release for specimen 1.

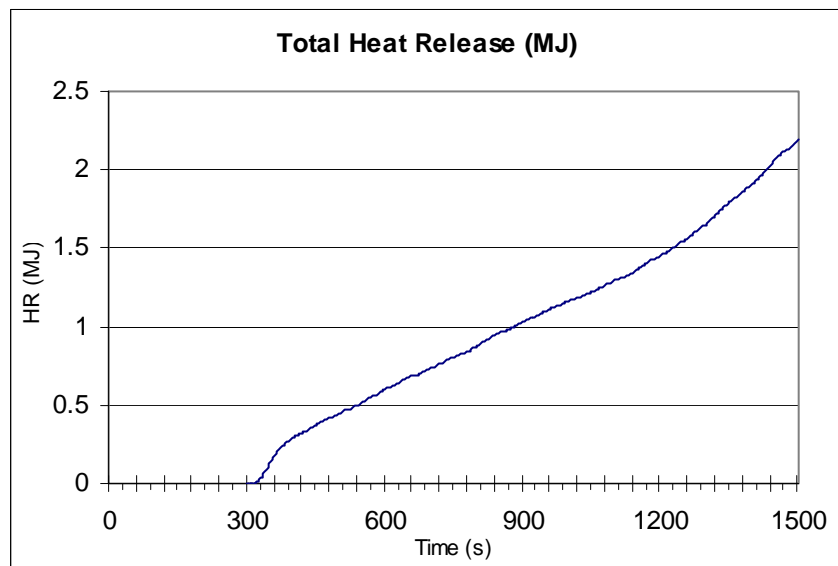
Figure 1b. Total heat release for specimen 1.

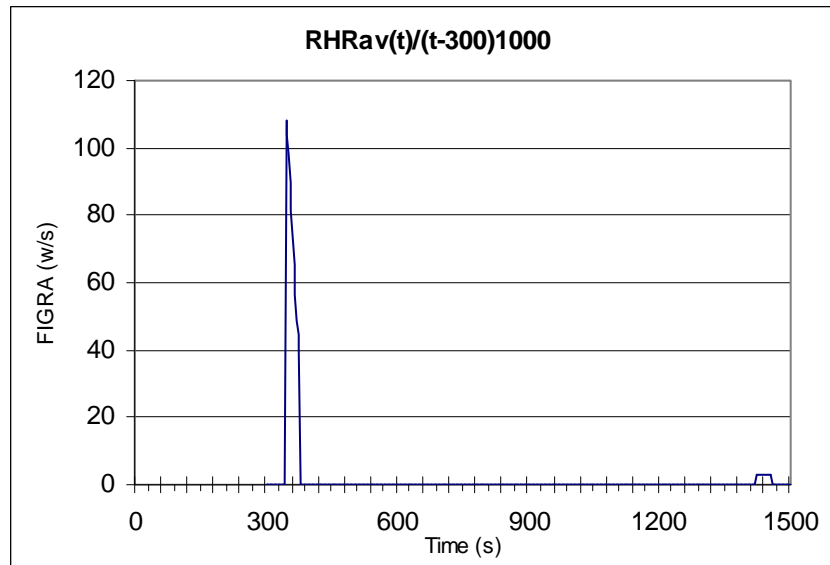
Figure 1c. Fire growth rate for specimen 1.

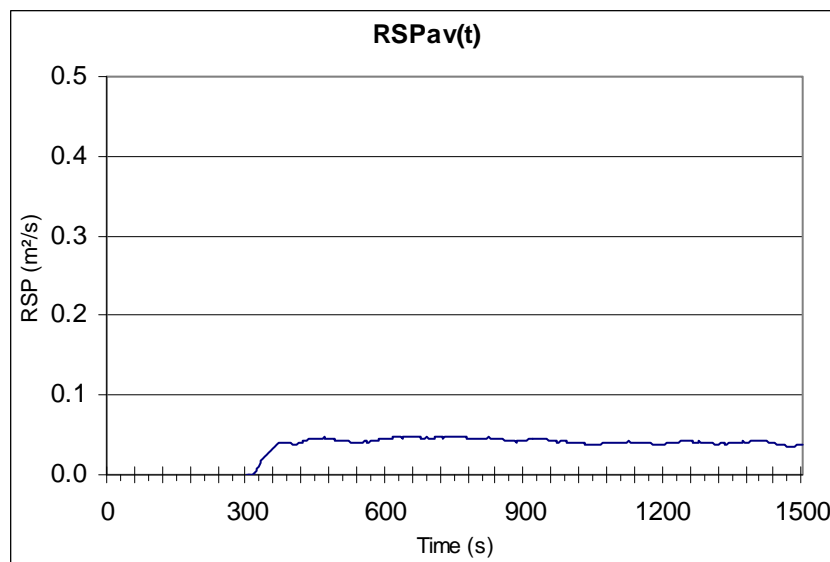
Figure 1d. Relative smoke production for specimen 1.

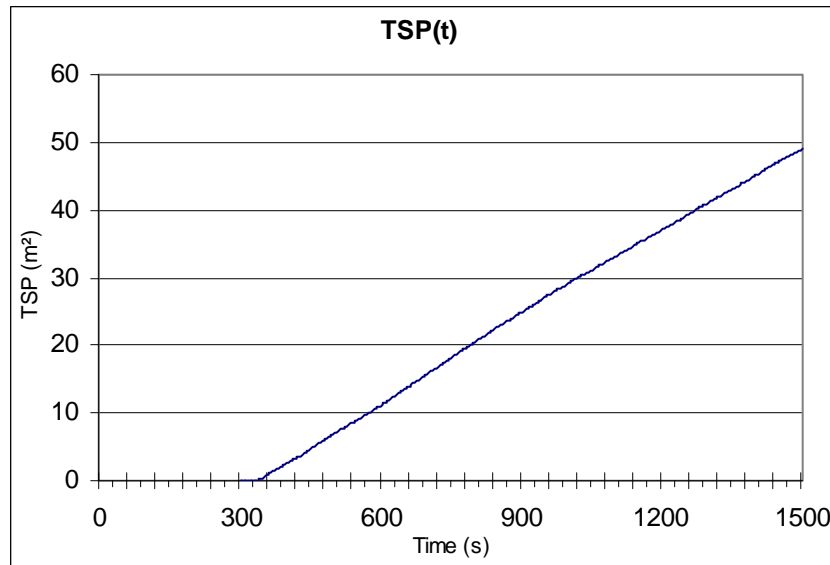
Figure 1e. Total smoke production for specimen 1.

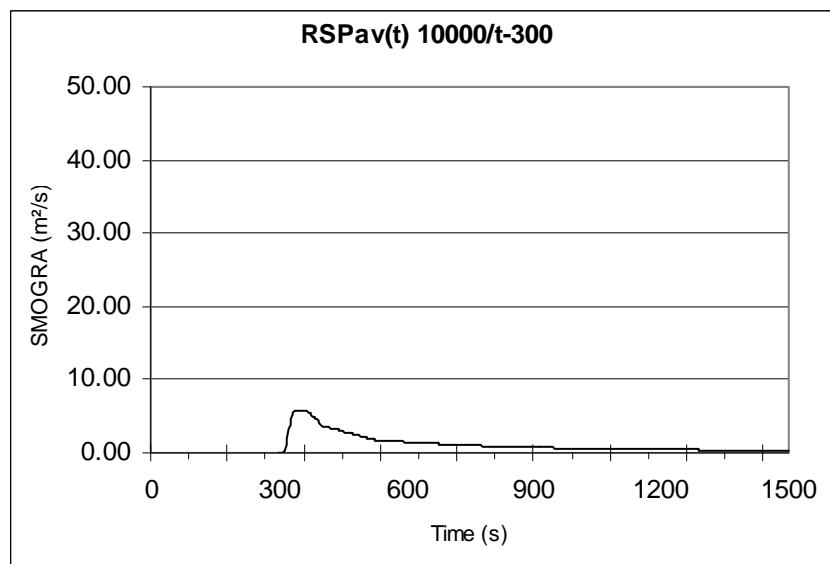
Figure 1f. Smoke growth rate for specimen 1.

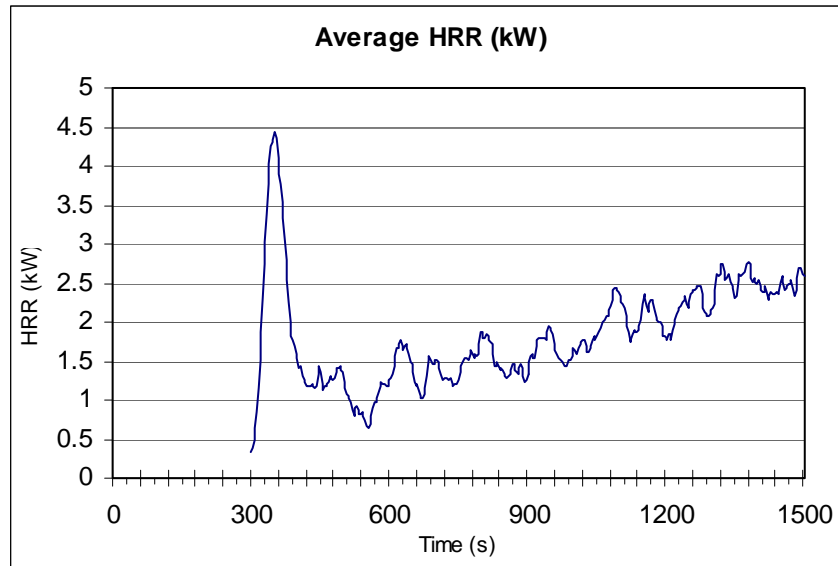
**Figure 2a.** Relative heat release for specimen 2.

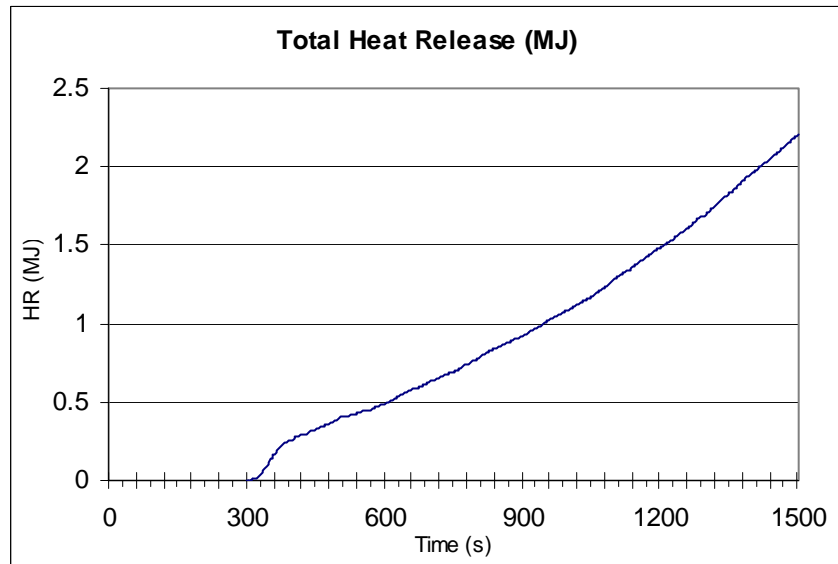
**Figure 2b.** Total heat release for specimen 2.

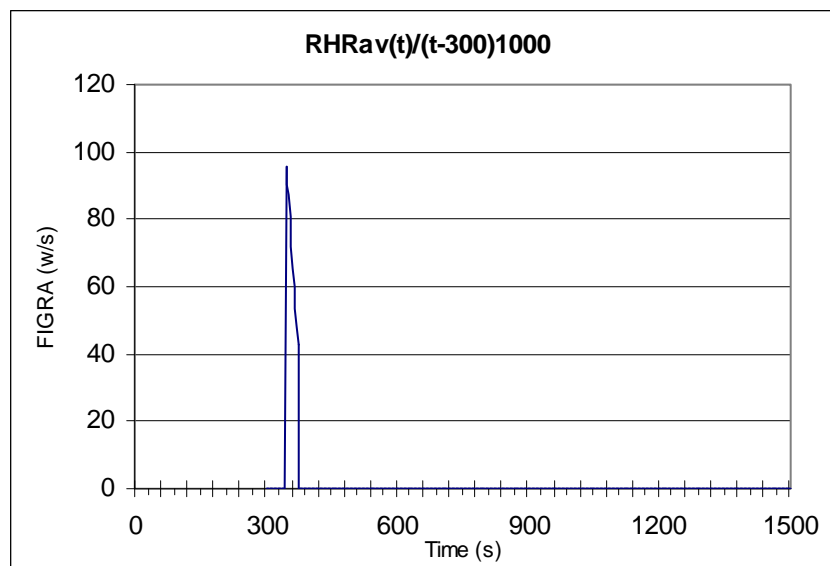
Figure 2c. Fire growth rate for specimen 2.

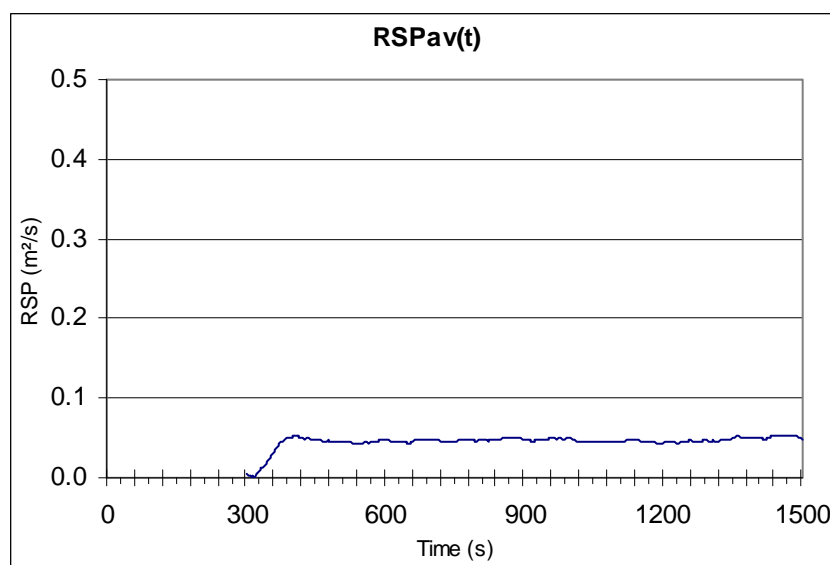
Figure 2d. Relative smoke production for specimen 2.

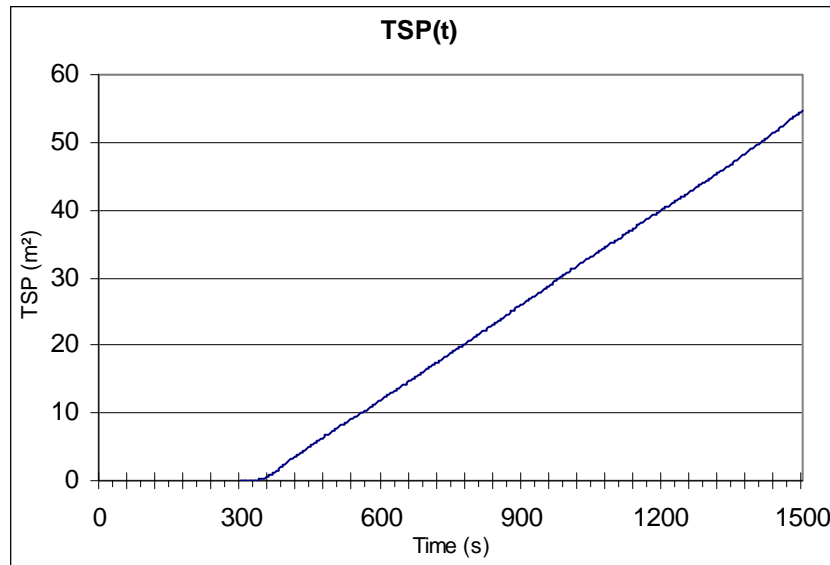
Figure 2e. Total smoke production for specimen 2.

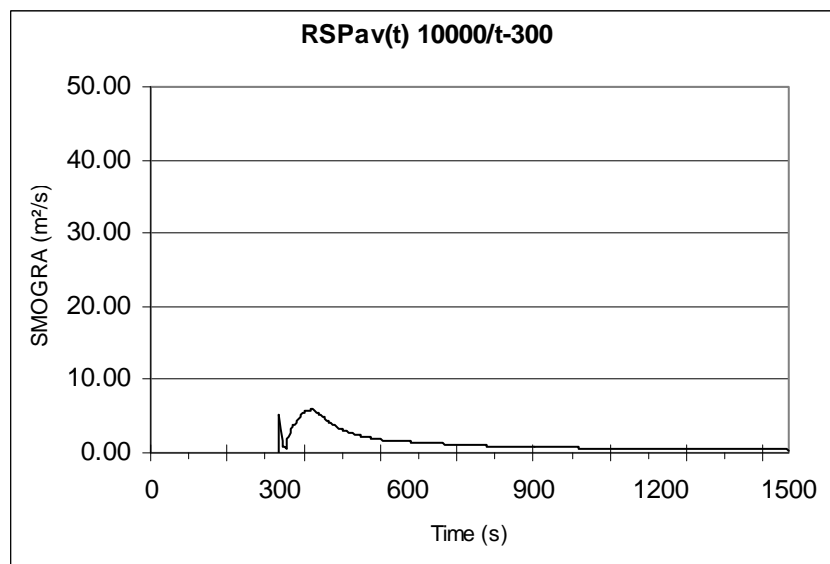
Figure 2f. Smoke growth rate for specimen 2.

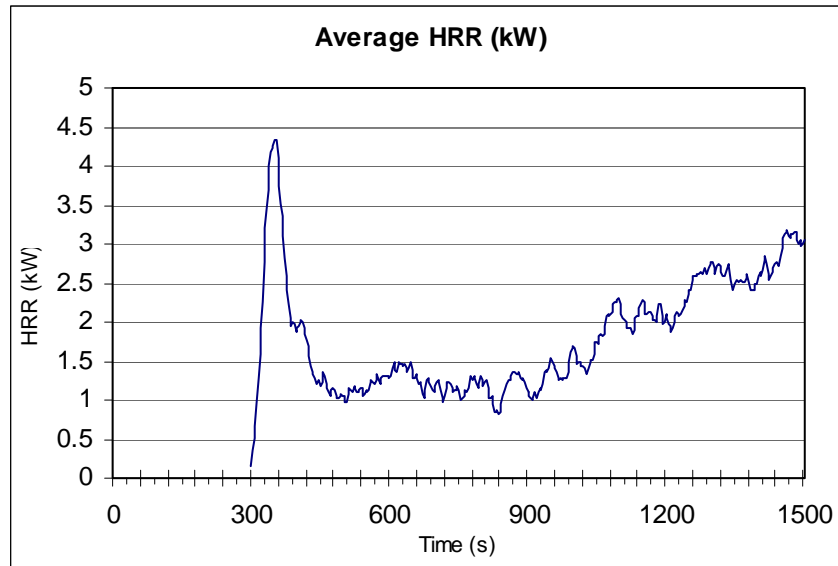
**Figure 3a.** Relative heat release for specimen 3.

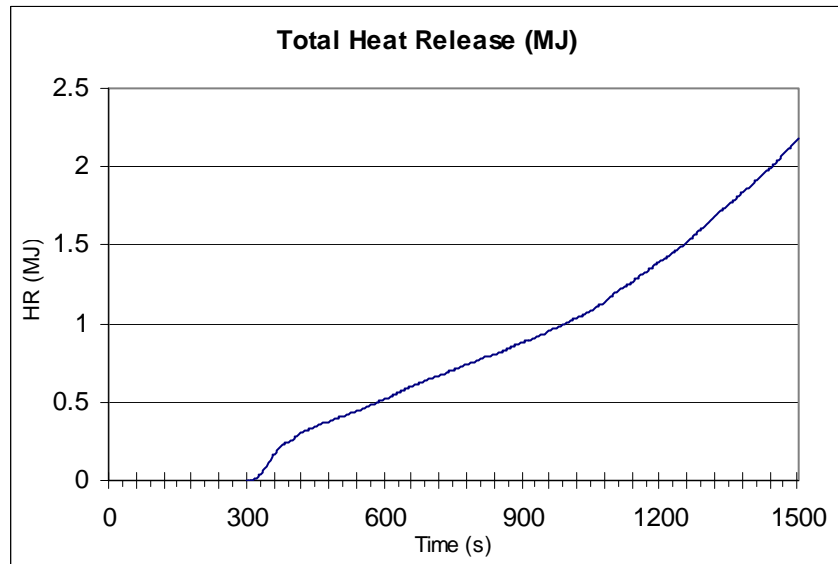
**Figure 3b.** Total heat release for specimen 3.

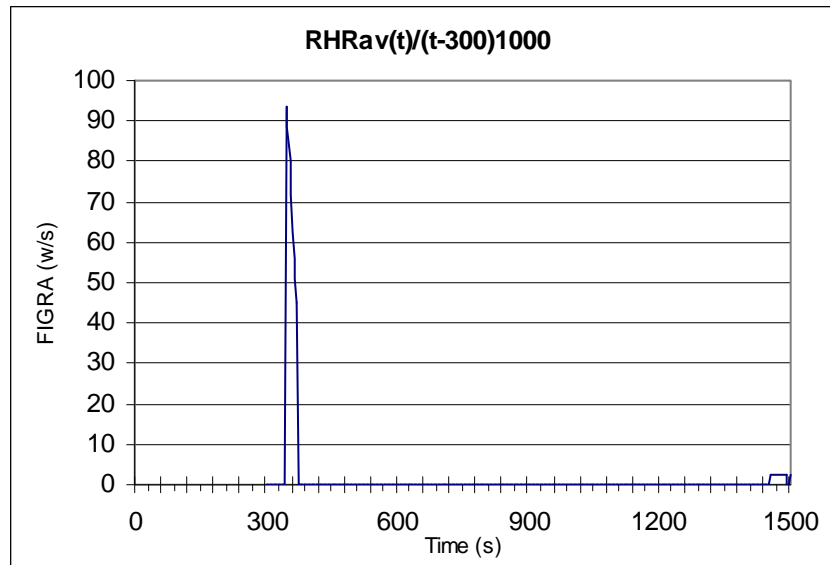
Figure 3c. Fire growth rate for specimen 3.

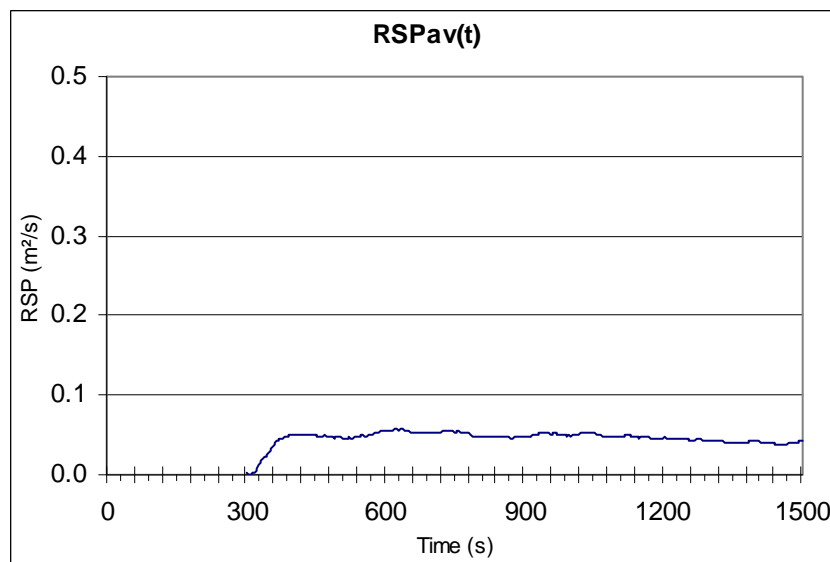
Figure 3d. Relative smoke production for specimen 3.

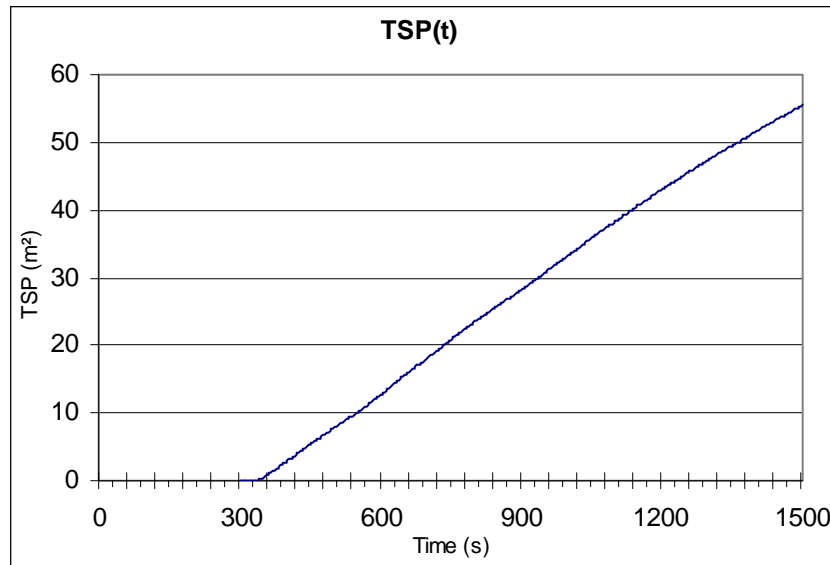
Figure 3e. Total smoke production for specimen 3.

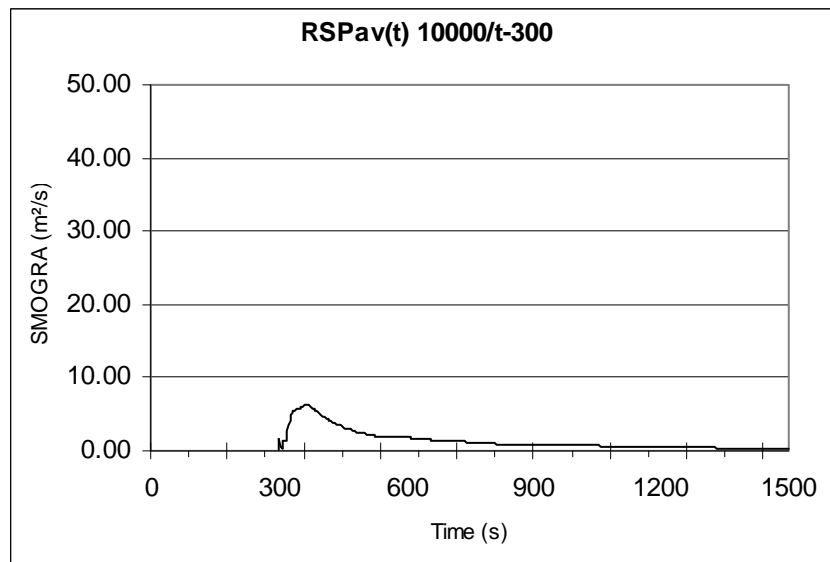
Figure 3f. Smoke growth rate for specimen 3.

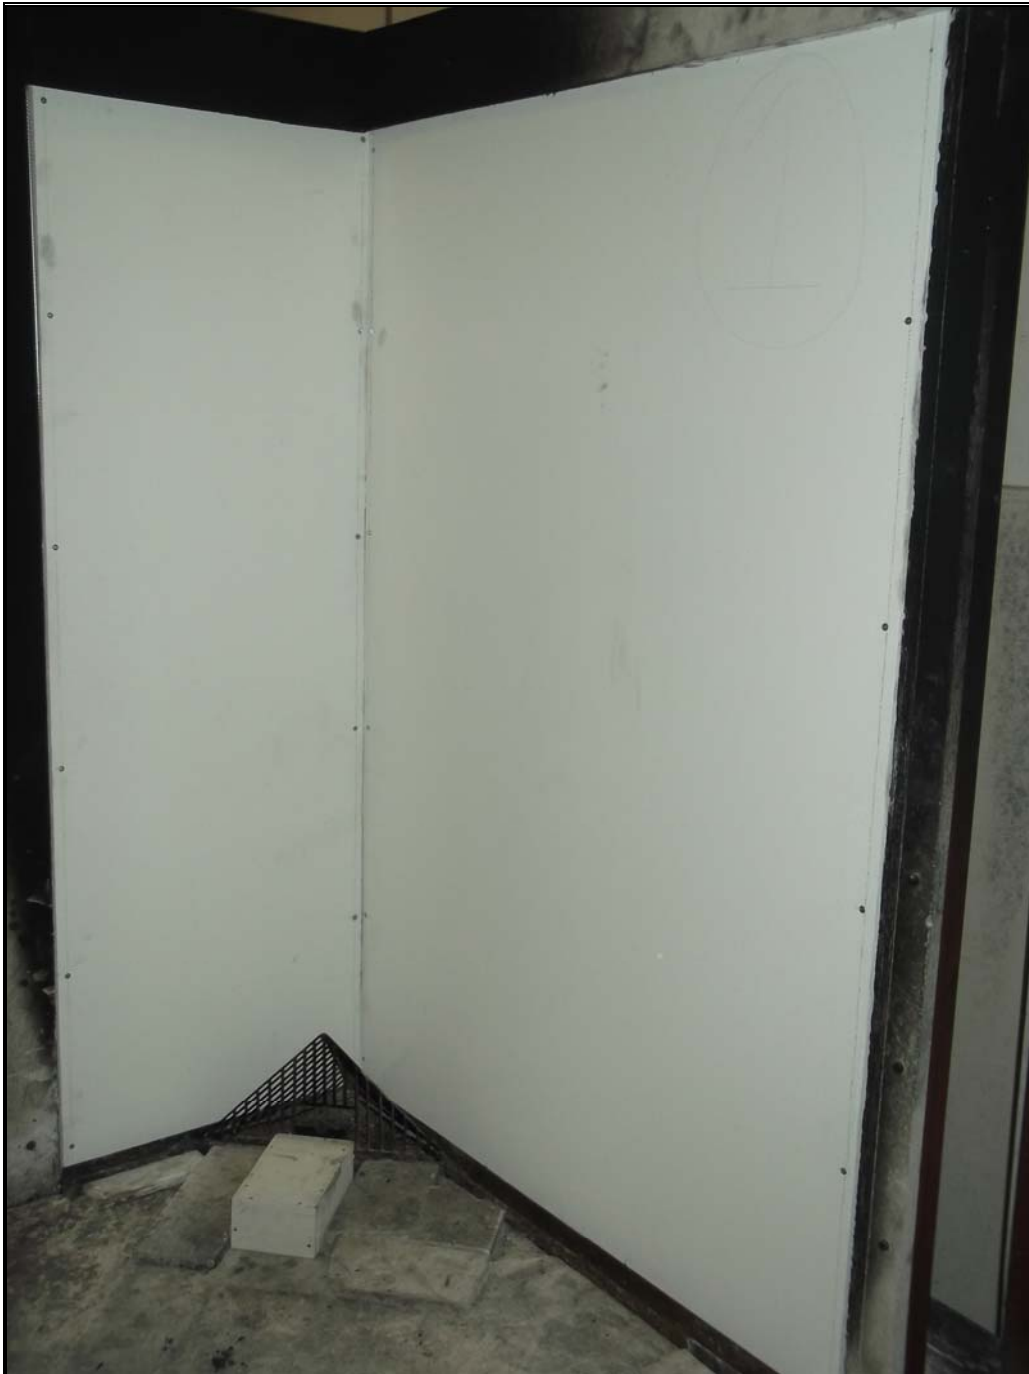
**Photograph 1.** Exposed surface (specimen 1).

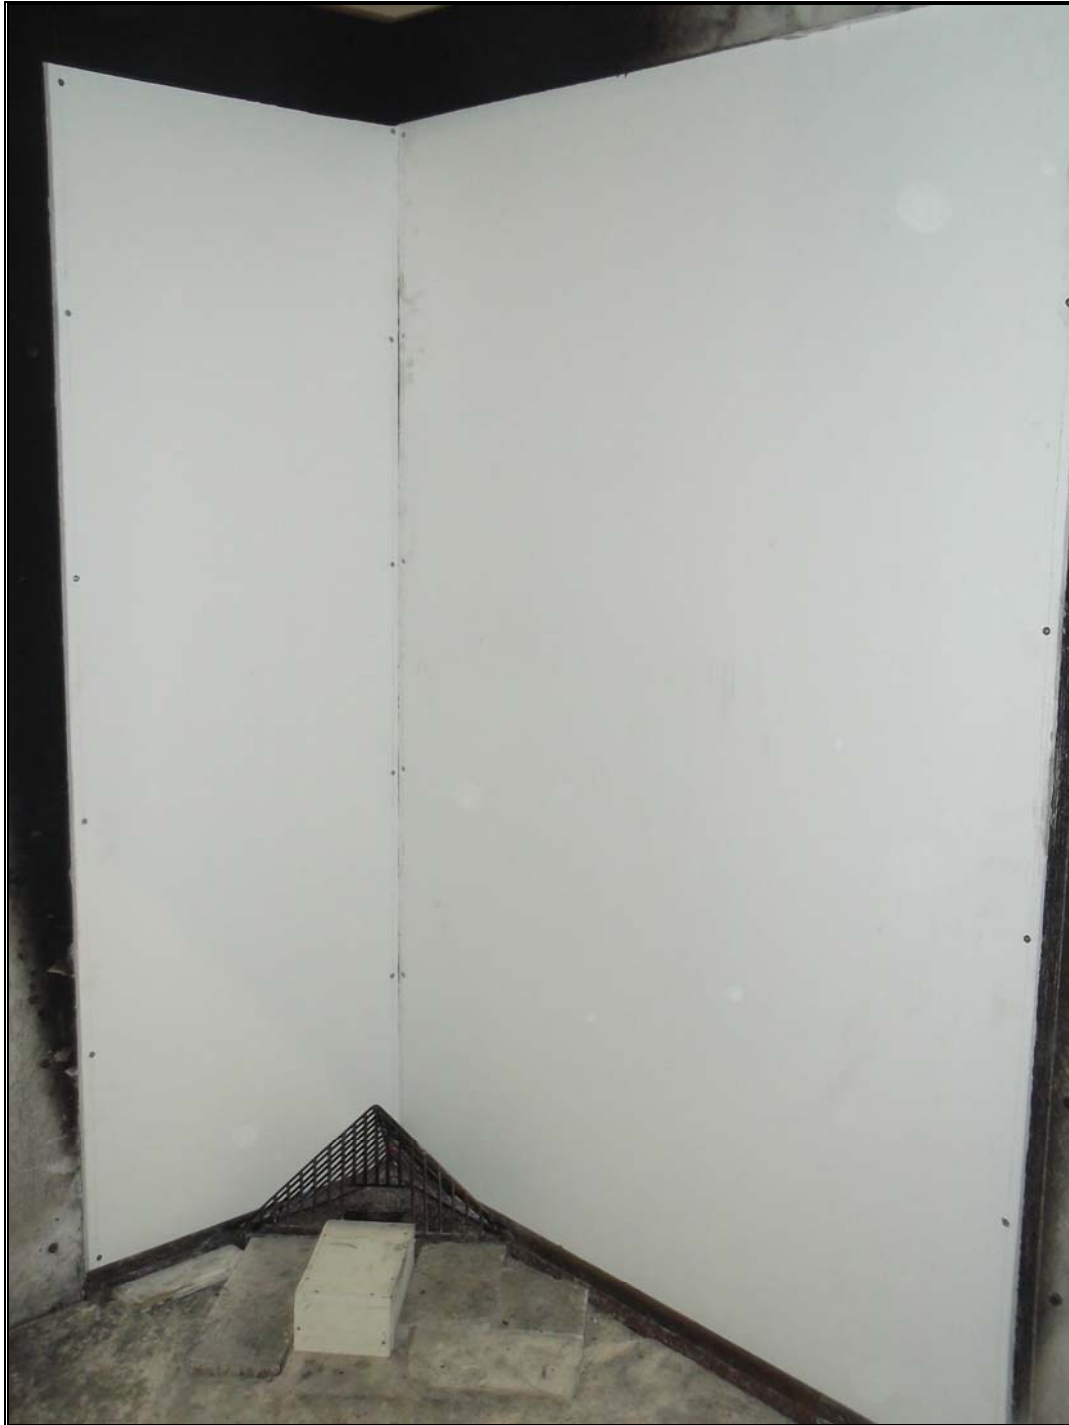
**Photograph 2.** Exposed surface (specimen 2)

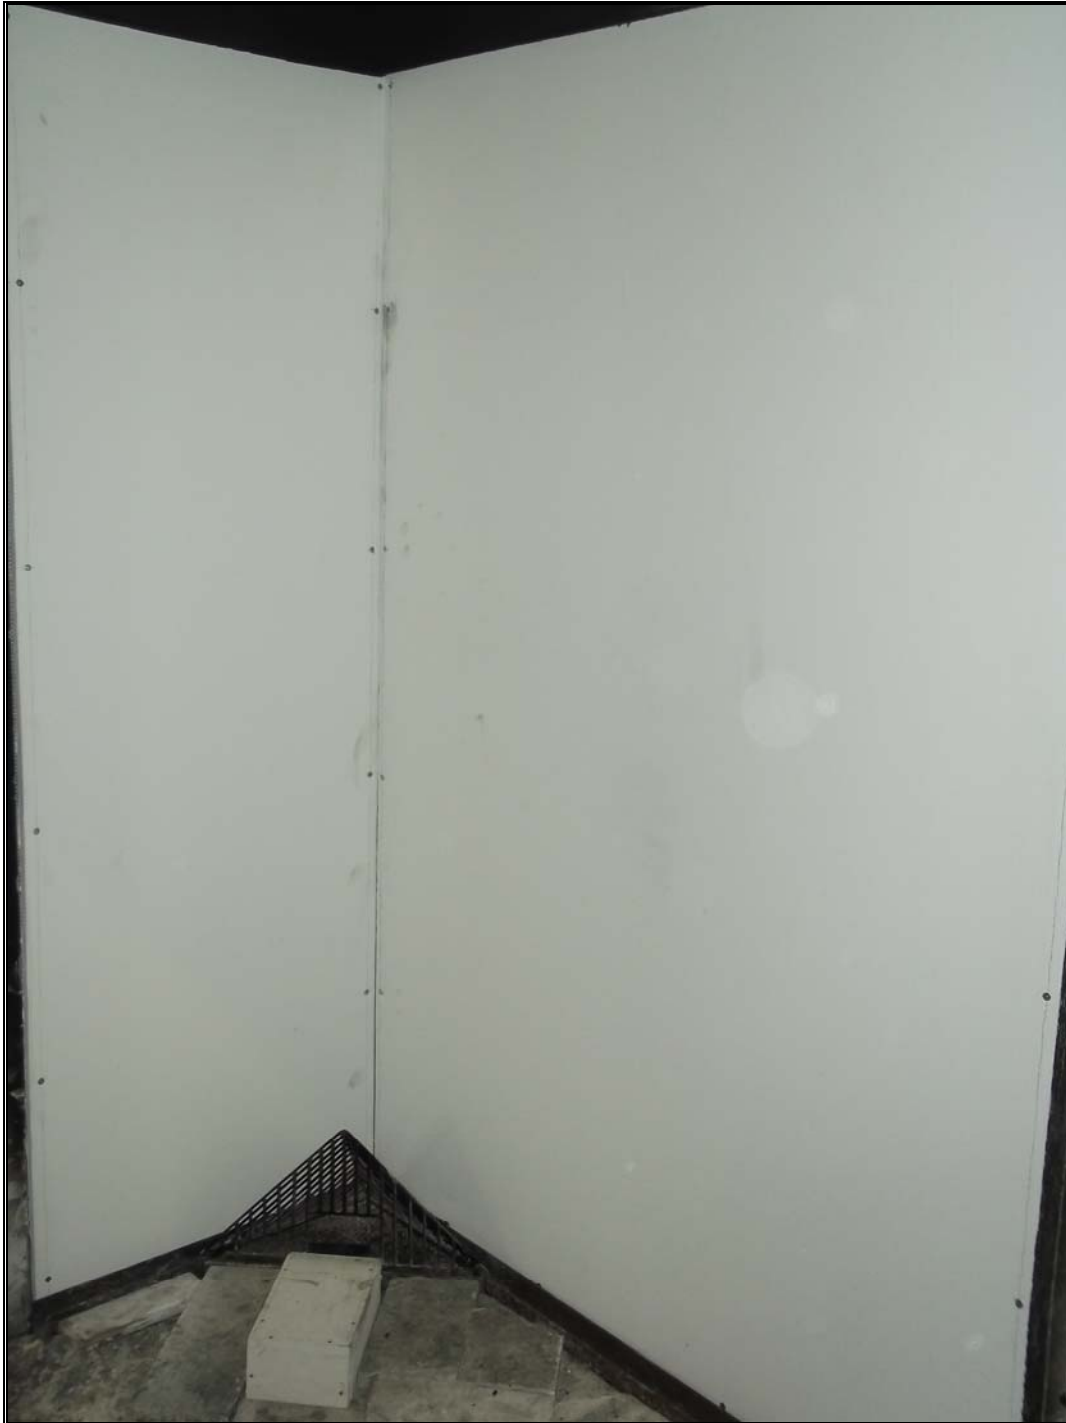
**Photograph 3.** Exposed surface (specimen 3)

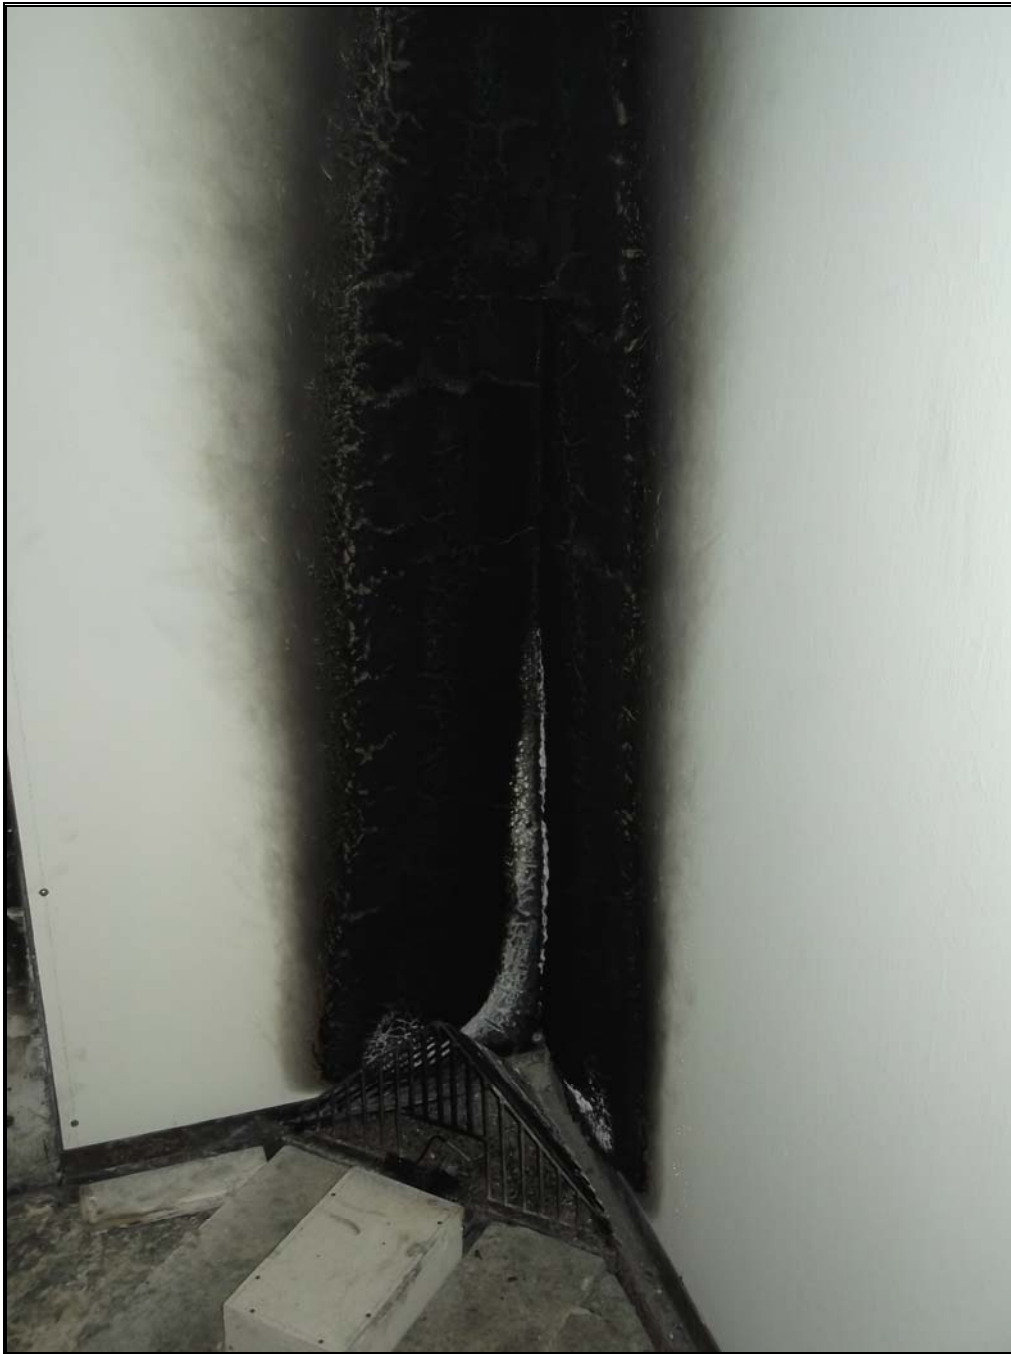
**Photograph 4.** Exposed surface (specimen 1)

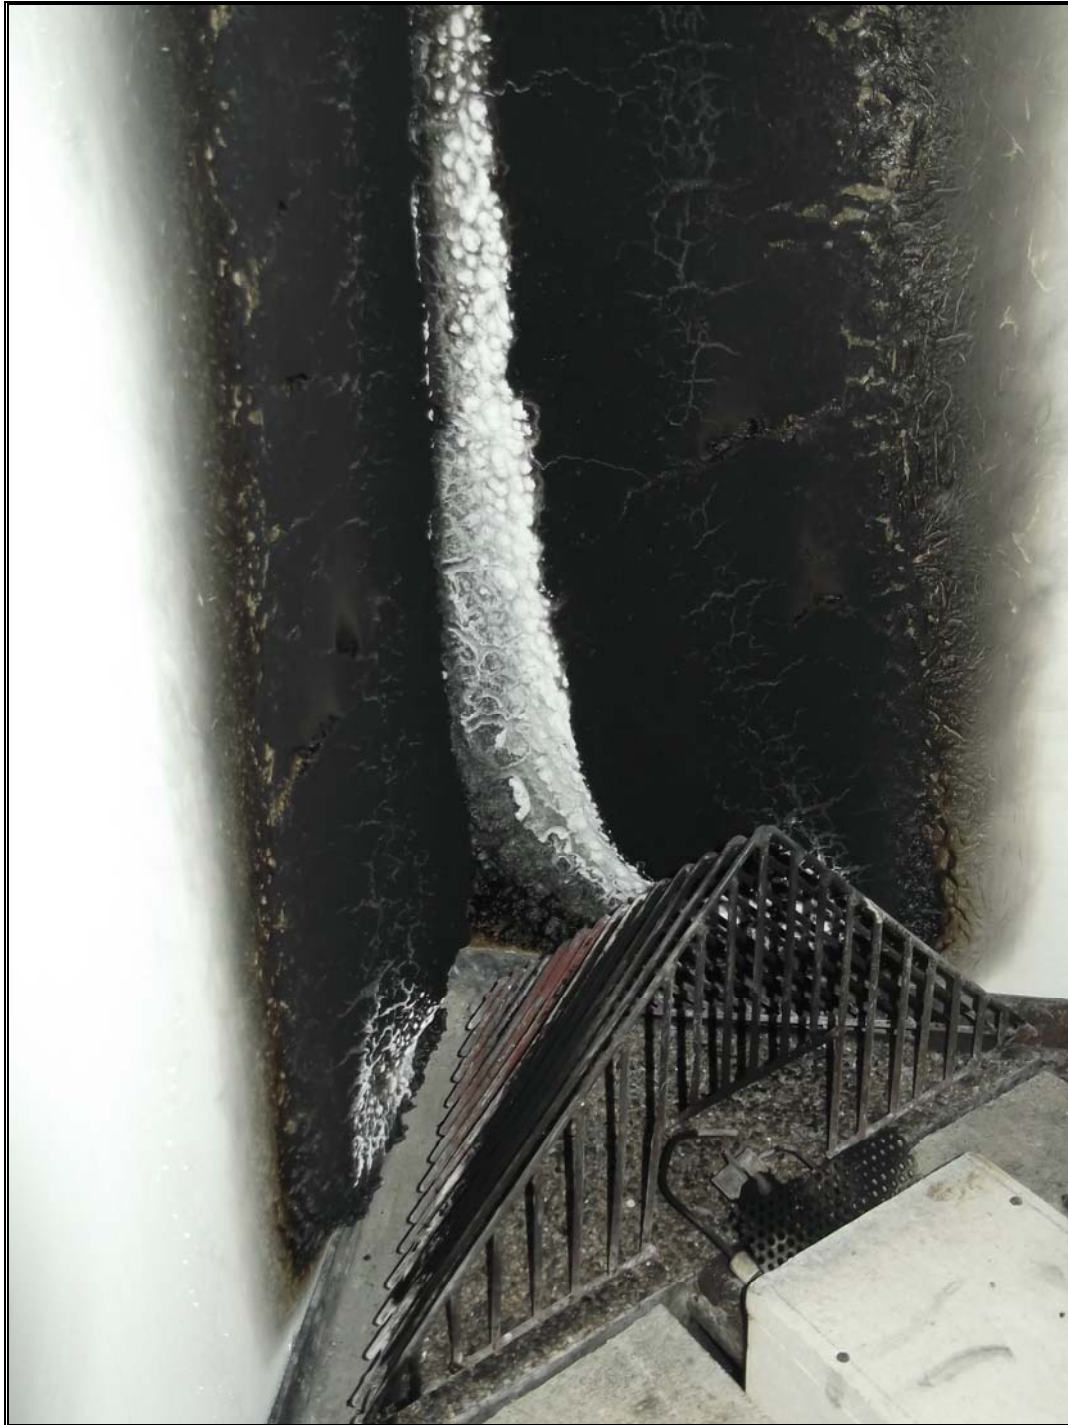
**Photograph 5.** Close-up on bottom corner (specimen 1)

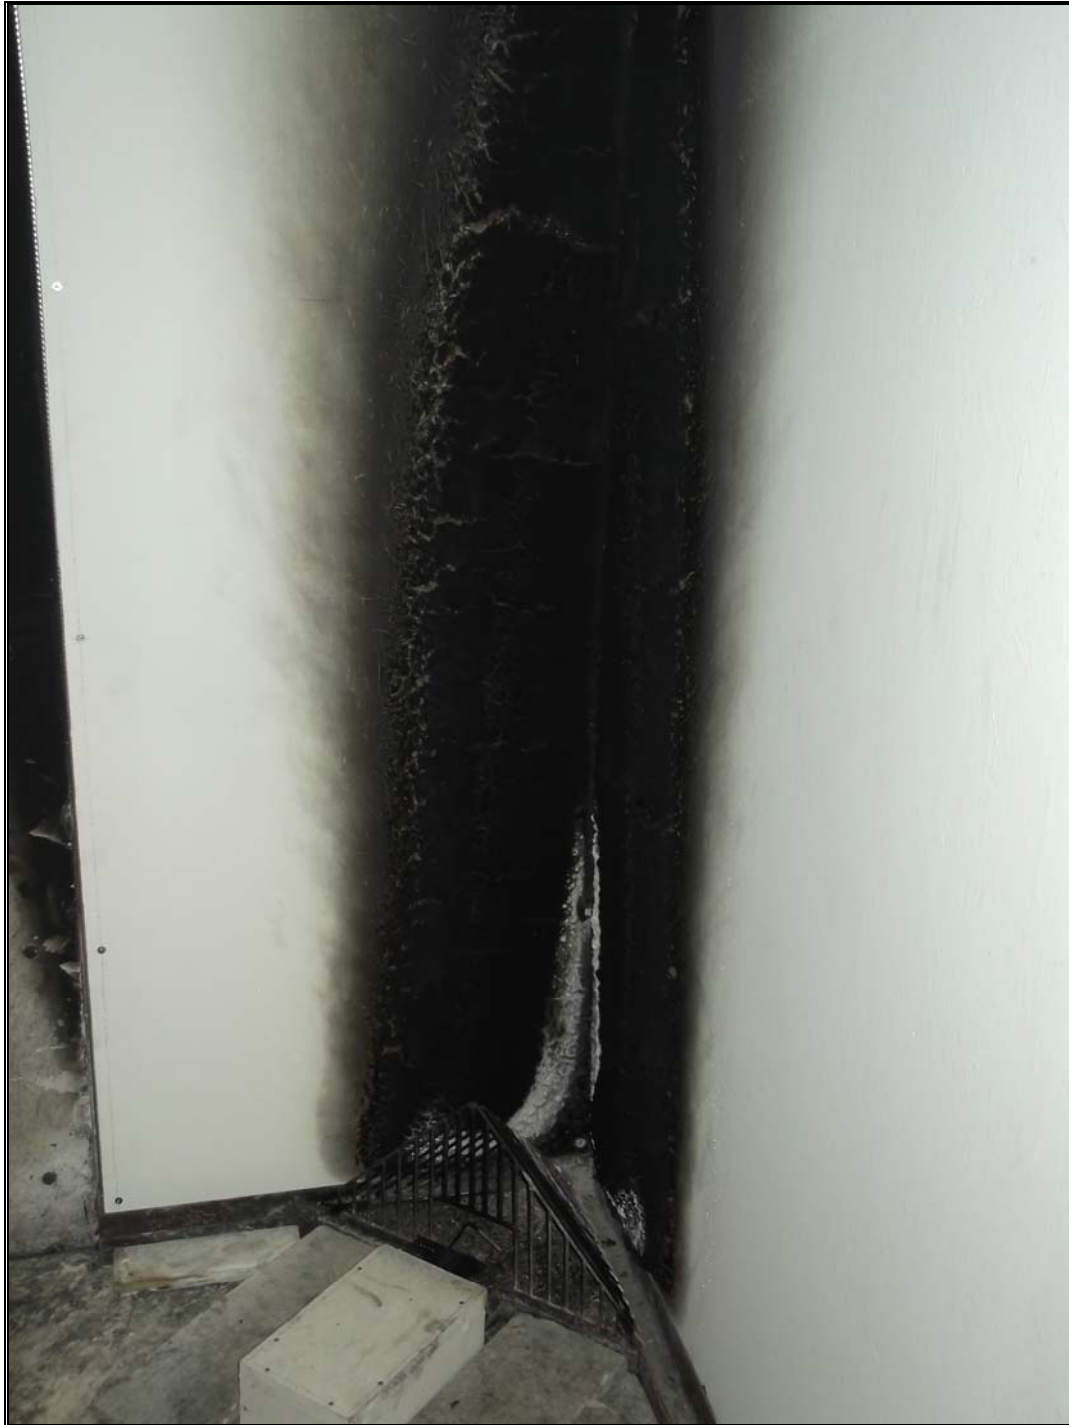
**Photograph 6.** Exposed surface (specimen 2)

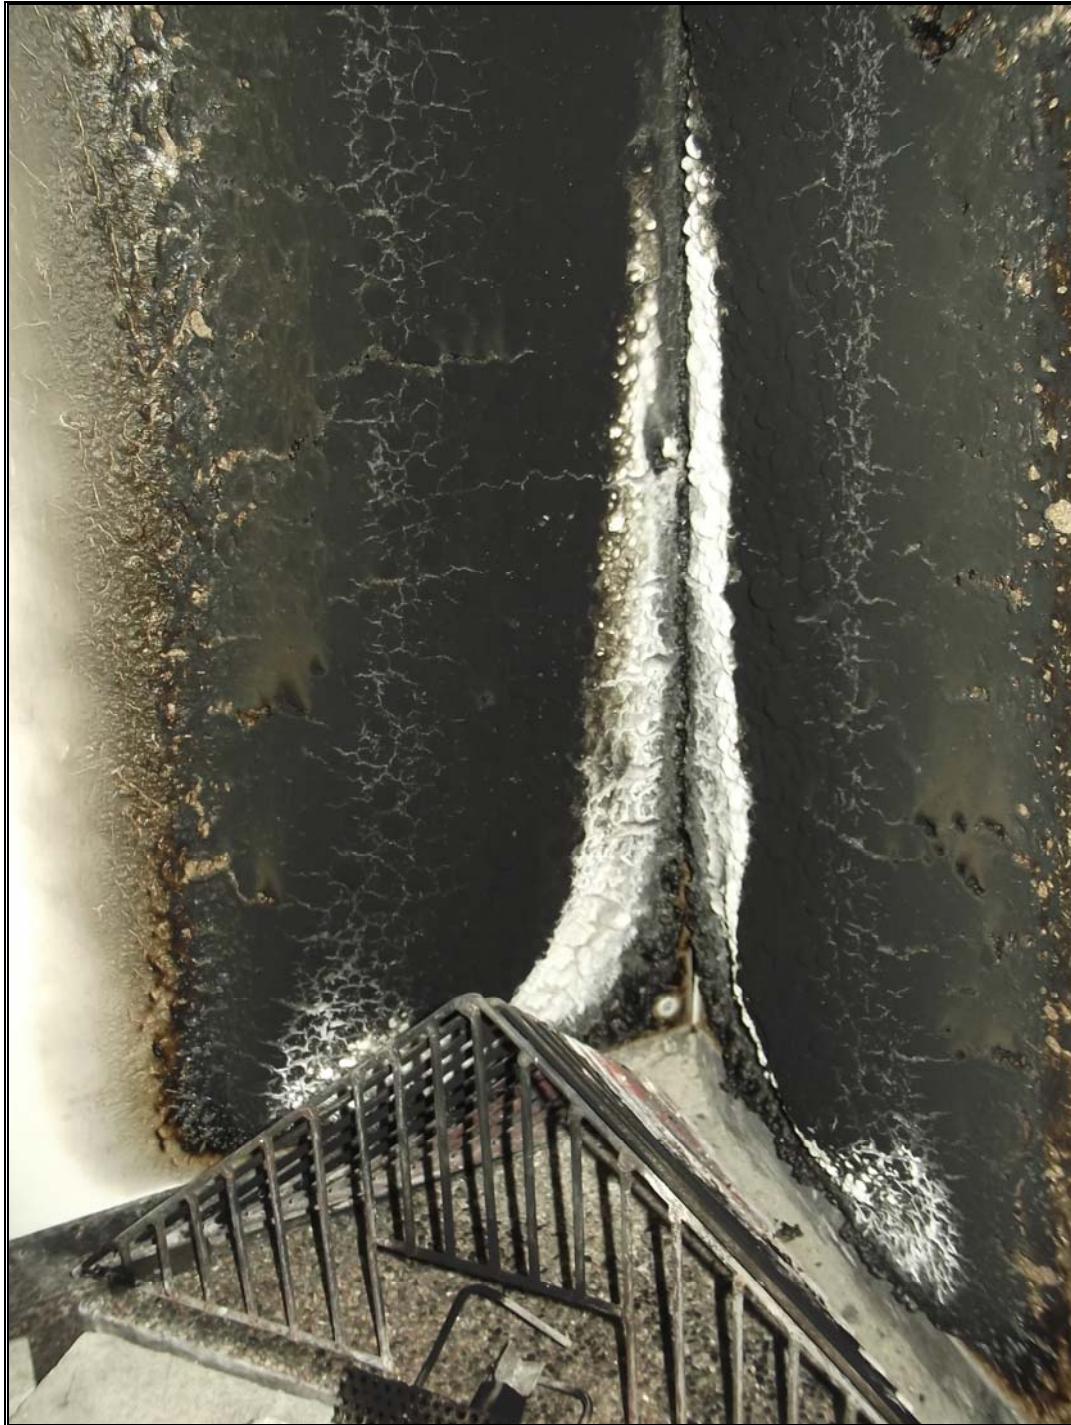
**Photograph 7.** Close-up of bottom corner (specimen 2)

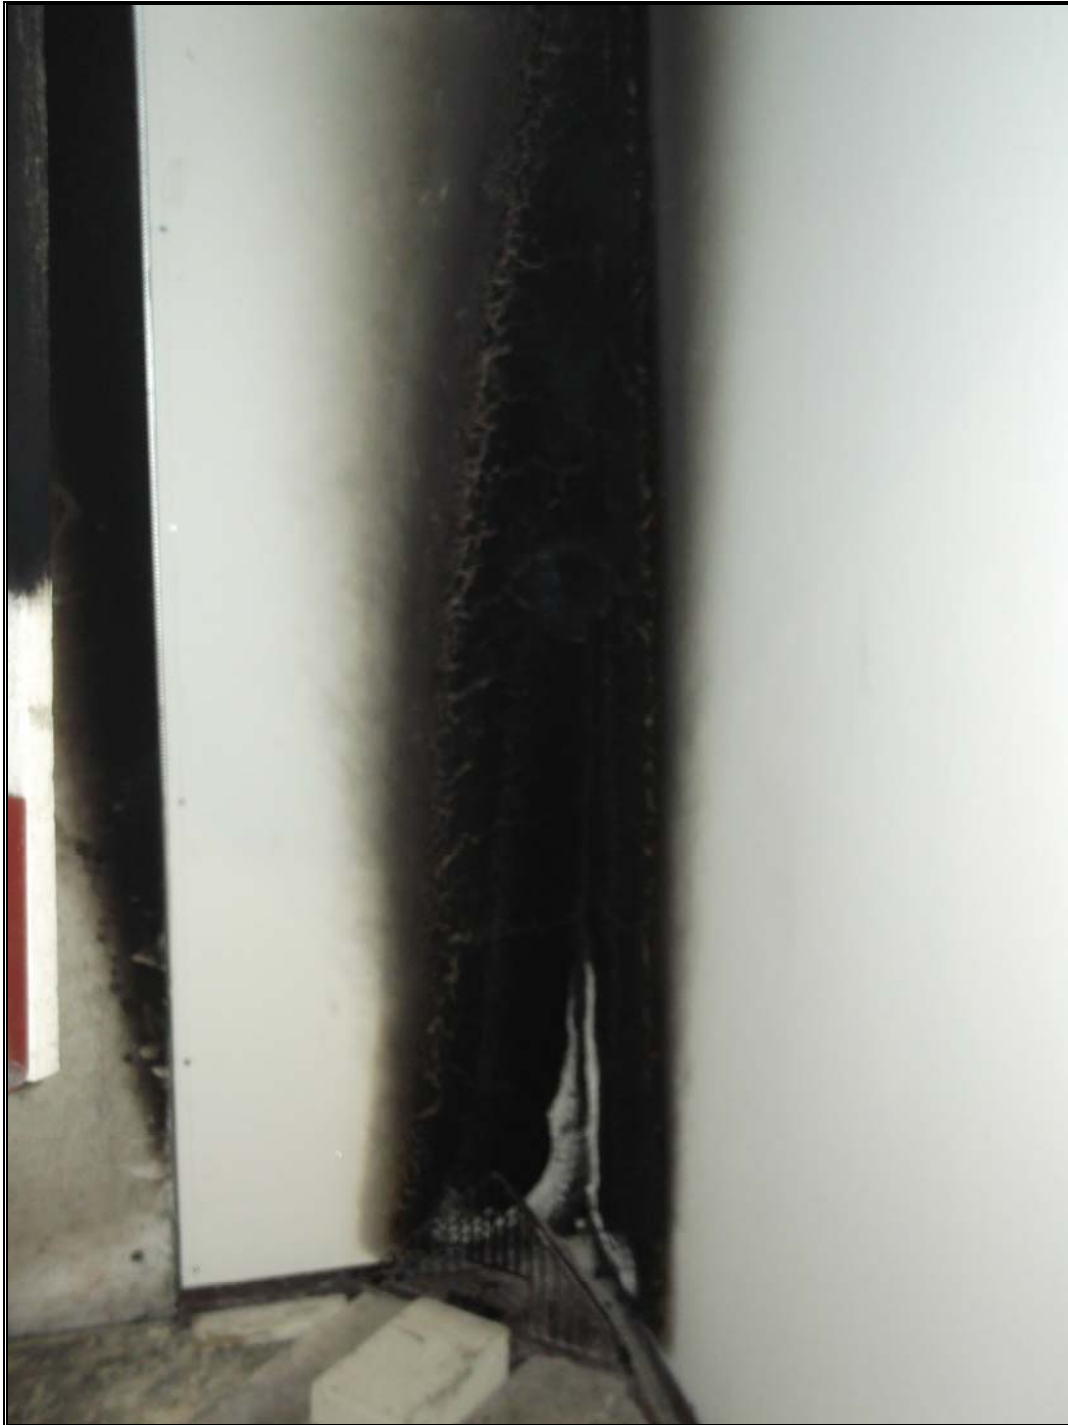
**Photograph 8.** Exposed surface (specimen 3)

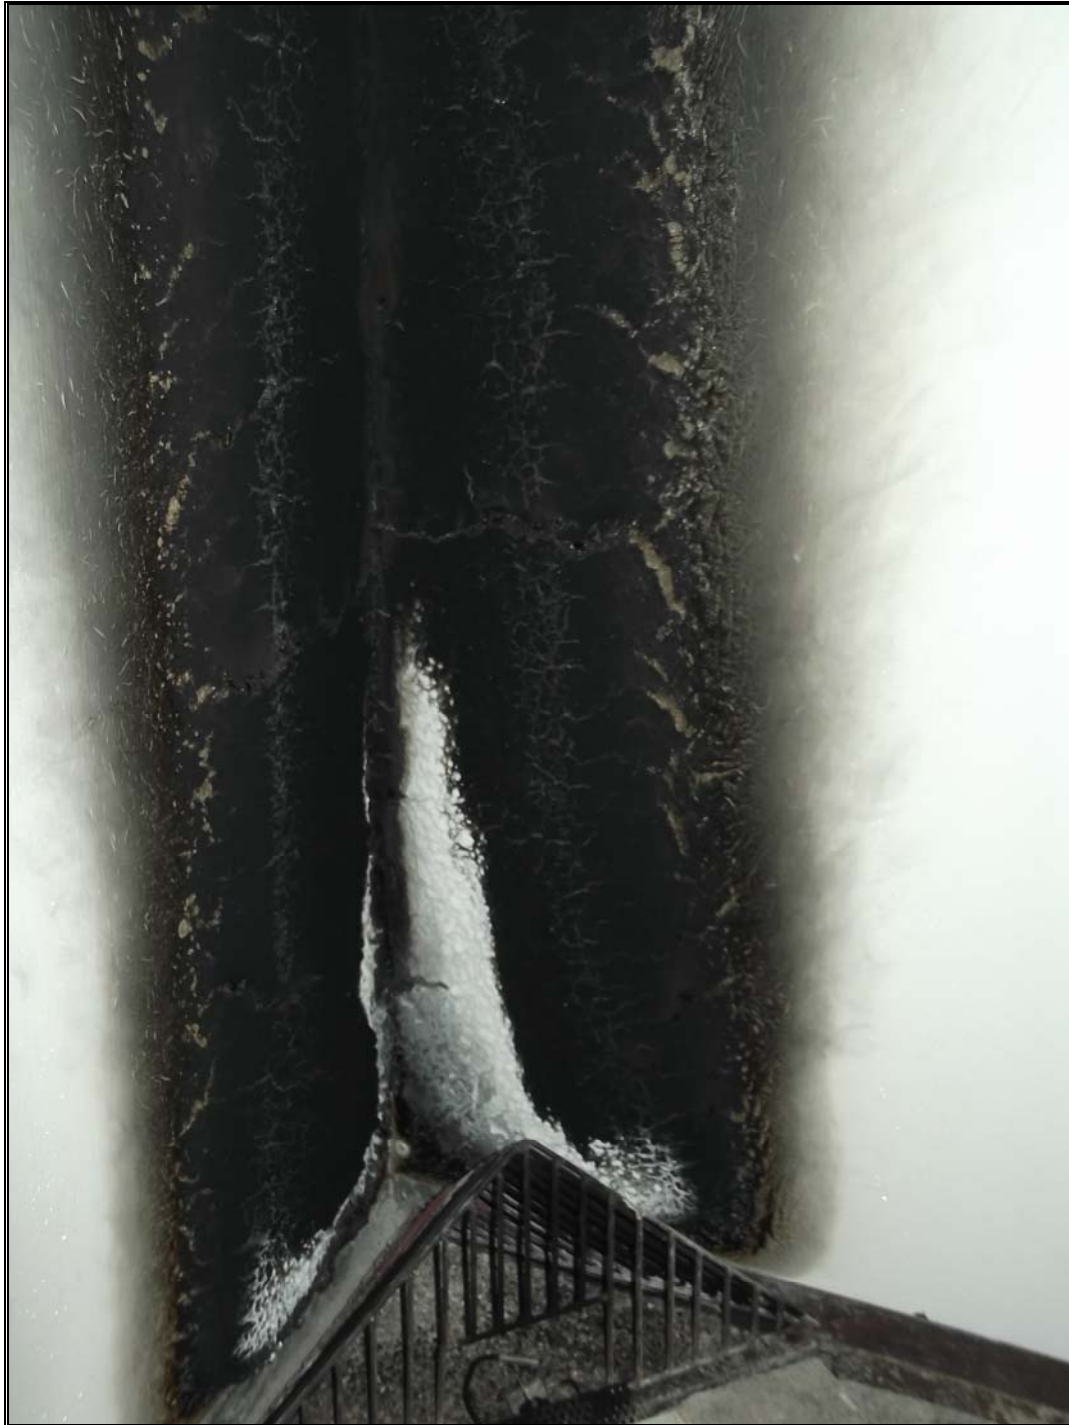
**Photograph 9.** Close-up of bottom corner (specimen 3)
