# TEST REPORT

**REPORT NUMBER: 100539045COQ-001**  
ORIGINAL ISSUE DATE: December 20, 2011

PRODUCT EVALUATED: 2x4 wood stud and OSB wall coated with  
Contego Intumescent Coating  
EVALUATION PROPERTY: Fire Resistance

**Report of testing 2x4 wood stud and OSB wall coated with  
Contego Intumescent Coating for compliance with the applicable  
requirements of the following criteria: 15 minute burn through  
under CAN/ULC S101-07 furnace conditions.**

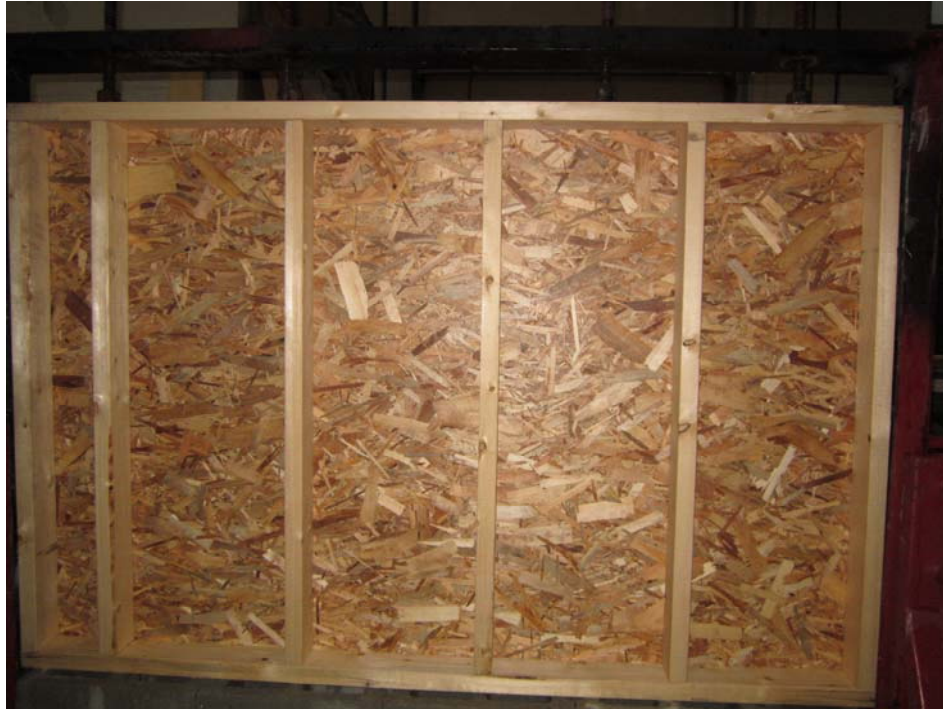
Unexposed Side Prior to the Fire Test

The test sample consisted of a 6 ft. wide by 4 ft. high wall constructed using nominal 2 in. by 4 in. wood studs, located 16 in. on centre with a single bottom and top plate. 3/8 in. thick OSB was fastened to one side of the framing. The coating, identified by the Client as "Contego Passive Fire Barrier" Latex Intumescent Coating, was applied to a thickness of 16 mil wet on the OSB side of the wall. The assembly was built and the coating was applied by the client.

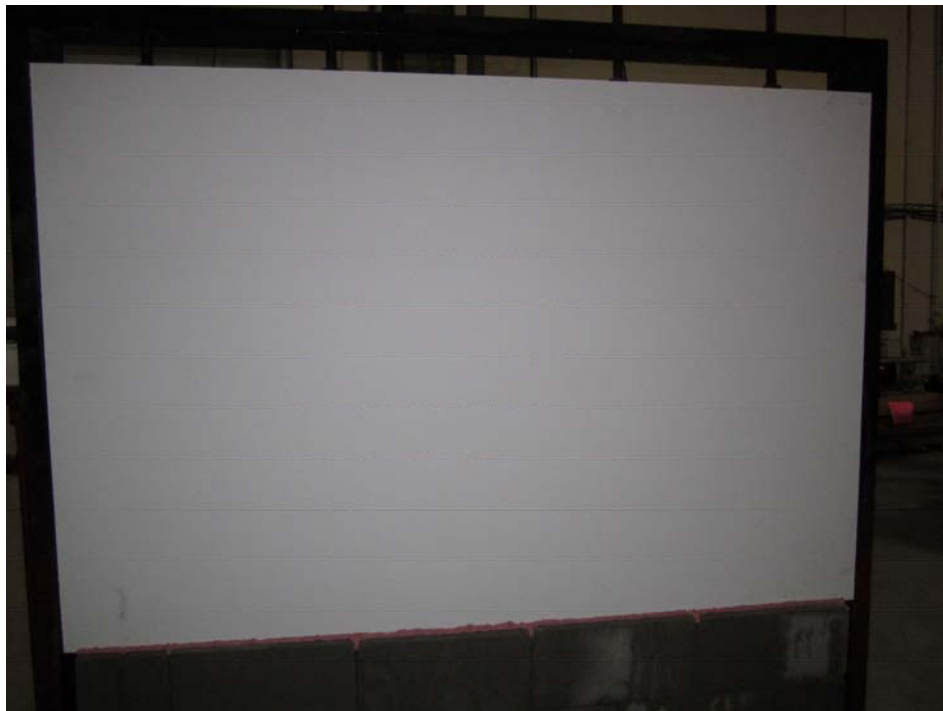
Exposed Side Prior to the Fire Test

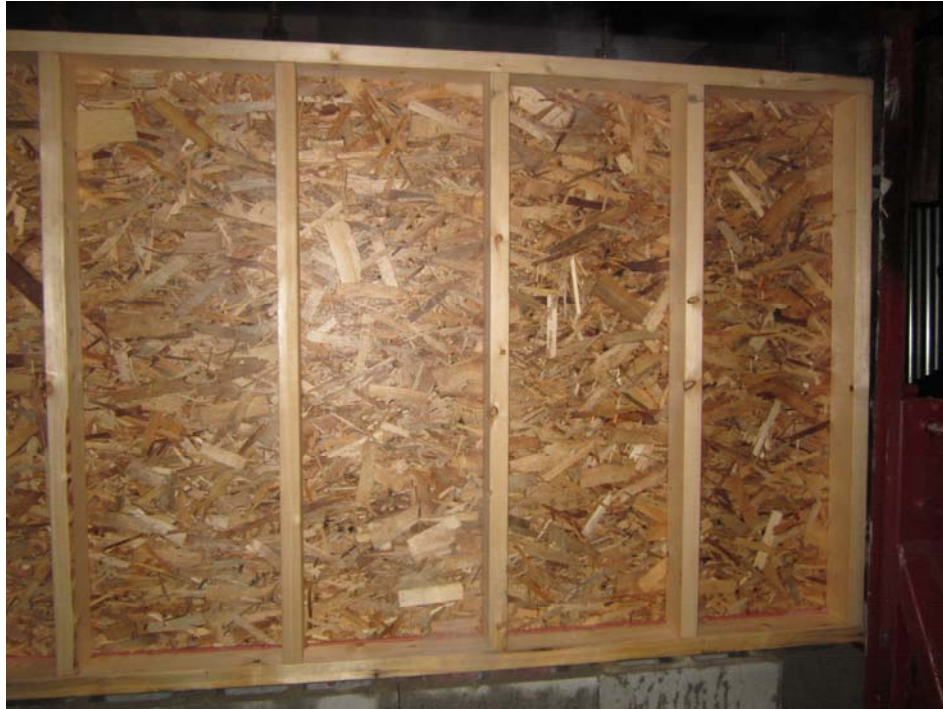
Unexposed Side During the Fire Test at 15 Minutes

Time (min.)	Exposed Side	Unexposed Side
1:14	Surface discolouration	
2:50	Light flaming on the surface	
4:10	Screw heads are exposed	
8:16	Minimal flaming on the surface	
9:16	Flaming increasing near the bottom of the panel	
10:15		Surface venting
11:40		Surface venting is increasing
12:00		Dark patches are appearing
15:00		Wall remains intact
17:30	Cracks are appearing on the surface	
23:00		More dark patches are appearing, studs are discolouring
25:25		Glowing at the bottom of the wall
25:35	Test discontinued	Flaming

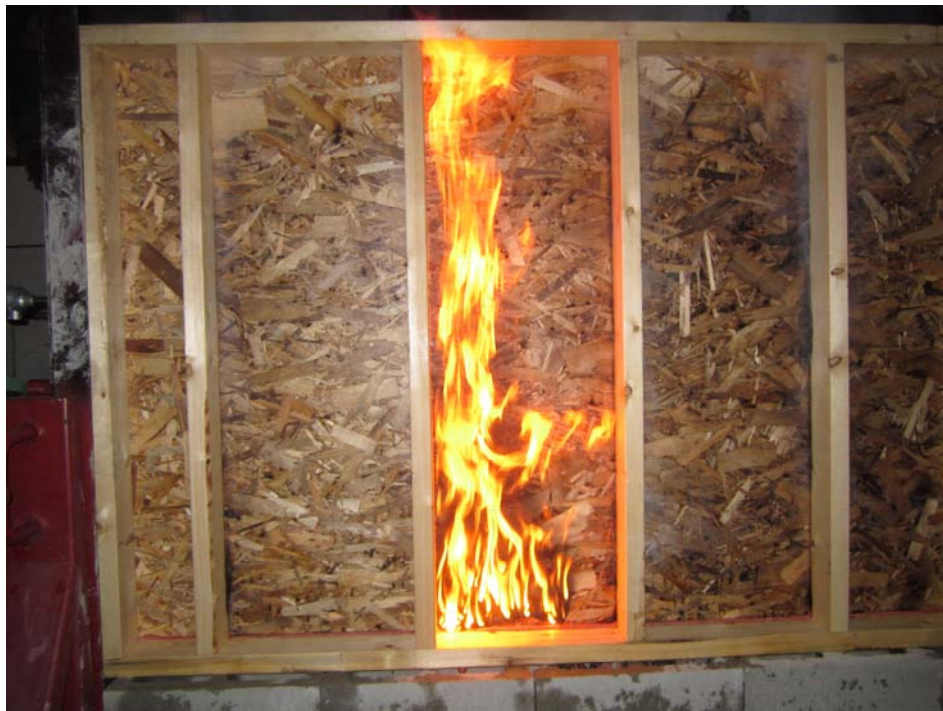
Unexposed Side After the Failure of the Fire Test

The Contego International Inc. pilot-scale wall assembly prevented burn through to the unexposed side of the entire area of the wall for 25 minutes 35 seconds when exposed to the furnace conditions of CAN/ULC S101-07, *Standard Test Methods for Fire Tests of Building Construction and Materials*. Consequently, the assembly met the requirements of preventing through openings and flaming on the unexposed side of the wall as specified by the Client.

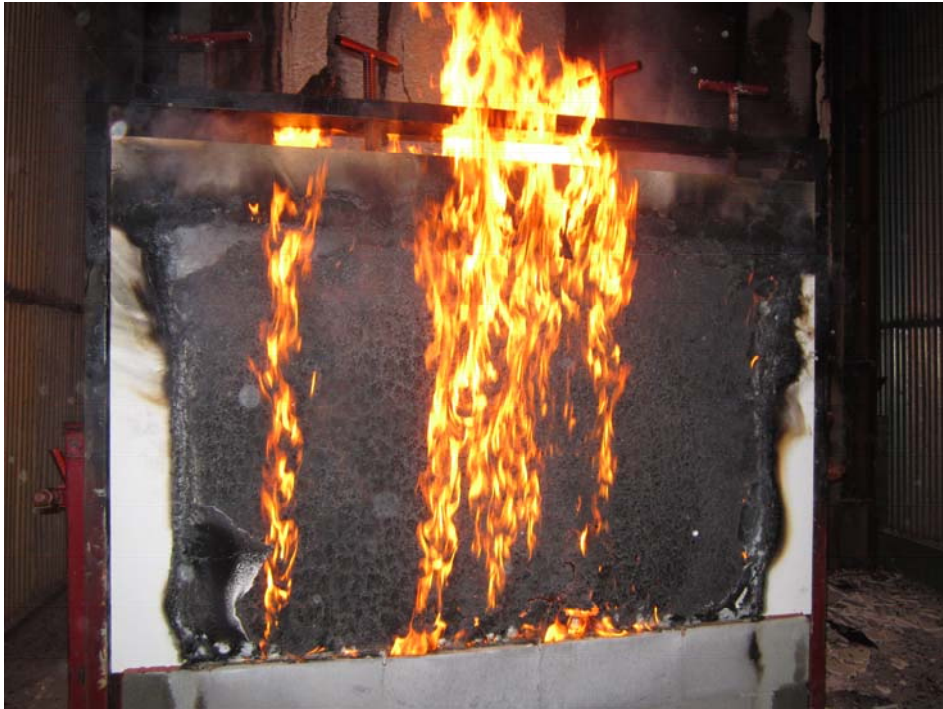
Exposed Side After the Fire Test

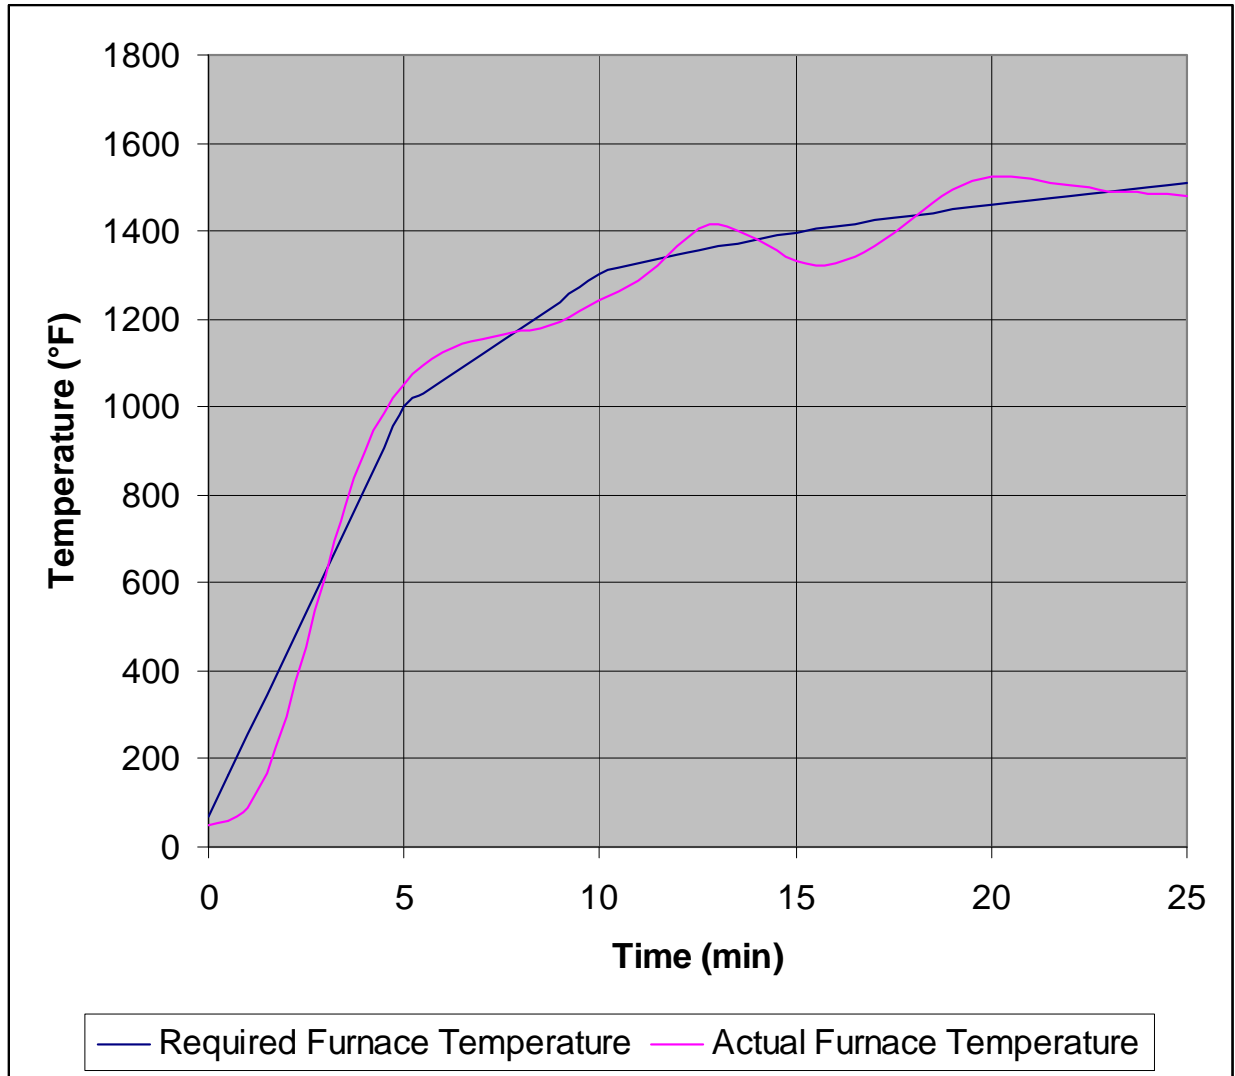
### TIME TEMPERATURE CURVE AVERAGE TEMPERATURE OF FURNACE DURING THE FIRE TEST

The temperatures inside the furnace are monitored by six equally spaced thermocouples. These readings were recorded by a Yokogawa data acquisition system (ID no. WH D3593/WH D3595) recorded every 30 seconds and displayed every 15 seconds. See Appendix B – Temperature Data. The wall assembly was subjected to the standard time/temperature curve of CAN/ULC S101-04 and the unexposed surface was observed.
